Rapid Preliminary Report:

Flooding of Cultural Heritage Repositories

Due to the Destruction of the Nova Kakhovka Dam on 6 June 2023

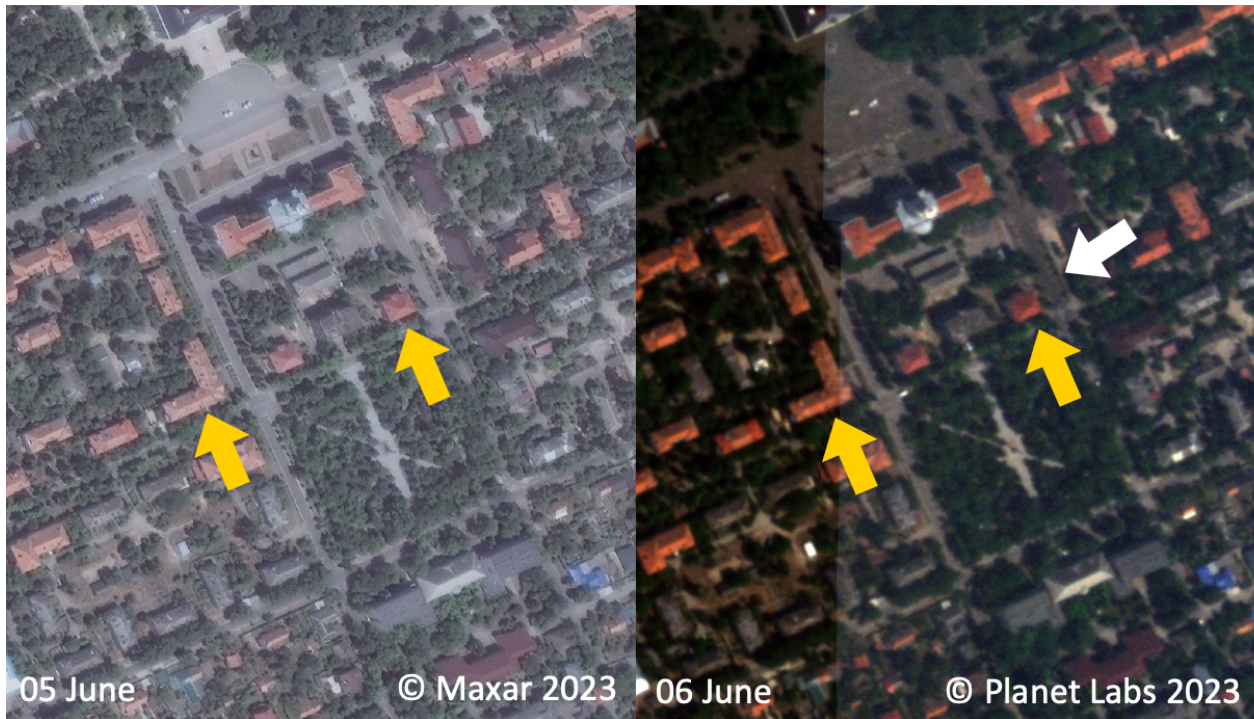
Novokakhovsk Art Gallery Named After Albin Havdzynskyi and the Museum of History of Nova Kakhovka: A comparison of satellite images captured on 5 June 2023 and 6 June 2023 (Image 1) shows extensive flooding in proximity to both museums. The yellow arrow on the left points to the Novokakhovsk Art Gallery Named After Albin Haydzynskyi (Новокаховська картинна галерея ім. А. Гавдзинського Новокаховської міської ради), with the water's edge 120 m north of the gallery. The yellow arrow on the right points to the Museum of History of Nova Kakhovka (Музей історії м. Нова

Каховка) and the white arrow points to water at the eastern side of the building on 6 June 2023 at 11:07 a.m. local time.

Image 1. A comparison of the Novokakhovsk Art Gallery Named After Albin Haydzyński and the Museum of History of Nova Kakhovka between 5 June 2023 and 6 June 2023 shows flooding near both cultural institutions.

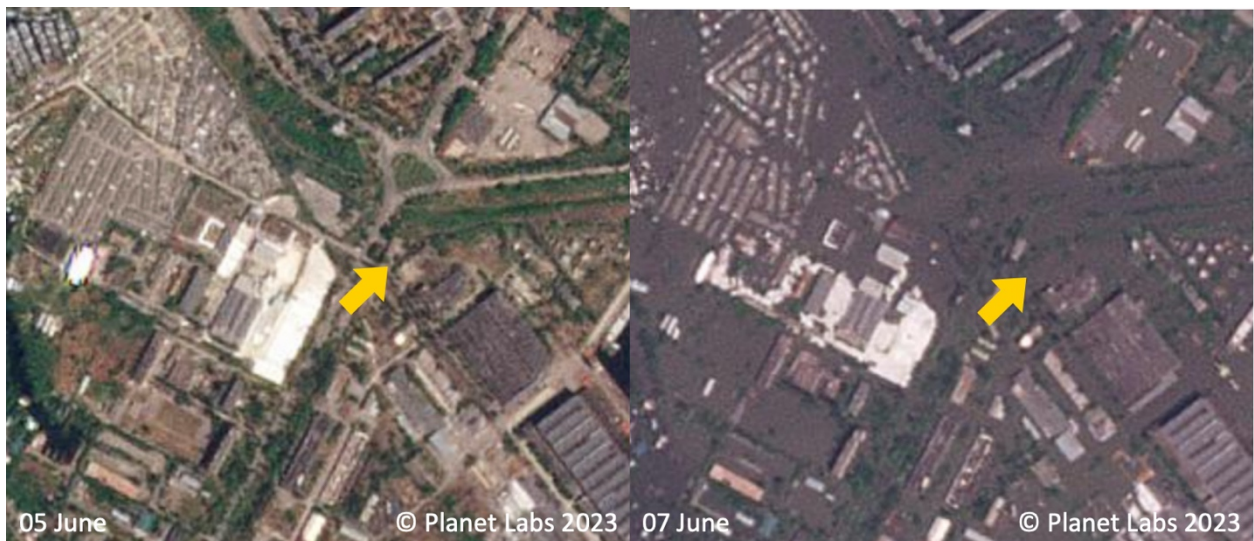
Museum of Battle Glory of the Danube Military Flotilla in Kherson: A comparison of satellite images captured on 5 June 2023 and 7 June 2023 (Image 2) shows extensive flooding at the Museum of Battle Glory of the Danube Military Flotilla in Kherson (Музей бойової слави Дунайської військової флотилії) on 7 June 2023 at 11:25 a.m. local time.

Image 2. A comparison of the Museum of Battle Glory of the Danube Military Flotilla in Kherson (Музей бойової

слави Дунайської військової флотилії) between 5 June 2023 and 7 June 2023 shows extensive flooding at the museum.

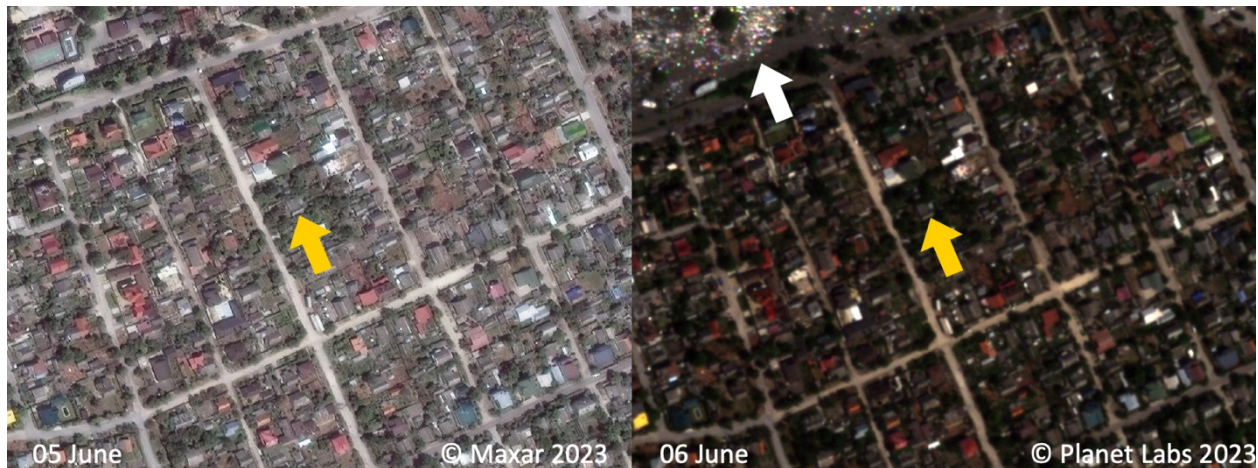
Literary and Memorial Museum of Anatolii Bakhuta of Nova Kakhovka: A comparison of satellite images captured on 5 June 2023 and 6 June 2023 (Image 3) shows flooding near the Literary and Memorial Museum of Anatolii Bakhuta (Будинок-музей А.П. Бахути) in Nova Kakhovka. The white arrow points to the water's edge reached within 120 m northwest of the museum on 6 June 2023 at 11:07 a.m. local time.

Image 3. A comparison of the Literary and Memorial Museum of Anatolii Bakhuta of Nova Kakhovka between 5 June 2023 and 6 June 2023 shows flooding in proximity of the museum.

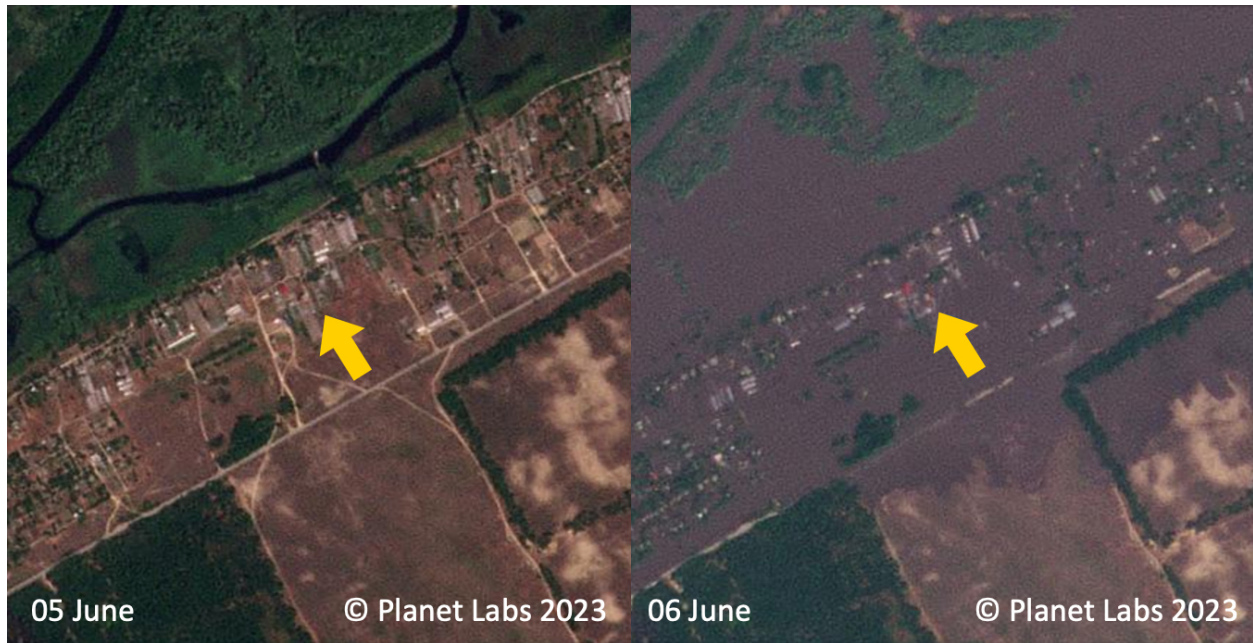
House Museum of Ostap Vyshnia in Kryuki Village, Tsurupins'k District, Kherson Region: A comparison of satellite images captured on 5 June 2023 and 6 June 2023 (Image 4) shows the flooding of the House Museum of Ostap Vyshnia in the village of Kryuki (Будинок, в якому жив письменник О. Вишня) on 6 June 2023 at 11:21 a.m. local time.

Image 4. A comparison of the House Museum of Ostap Vyshnia between 5 June 2023 and 6 June 2023 shows extensive flooding.
