Analysis of Damage to Ukrainian Cultural Heritage Sites: A Case Study as of 08 June 2022

Virginia Museum of Natural History, Cultural Heritage Monitoring Lab (CHML);
University of Maryland, Center for International Development & Conflict
Management (CIDCM); and Smithsonian Institution, Smithsonian Cultural Rescue
Initiative (SCRI)

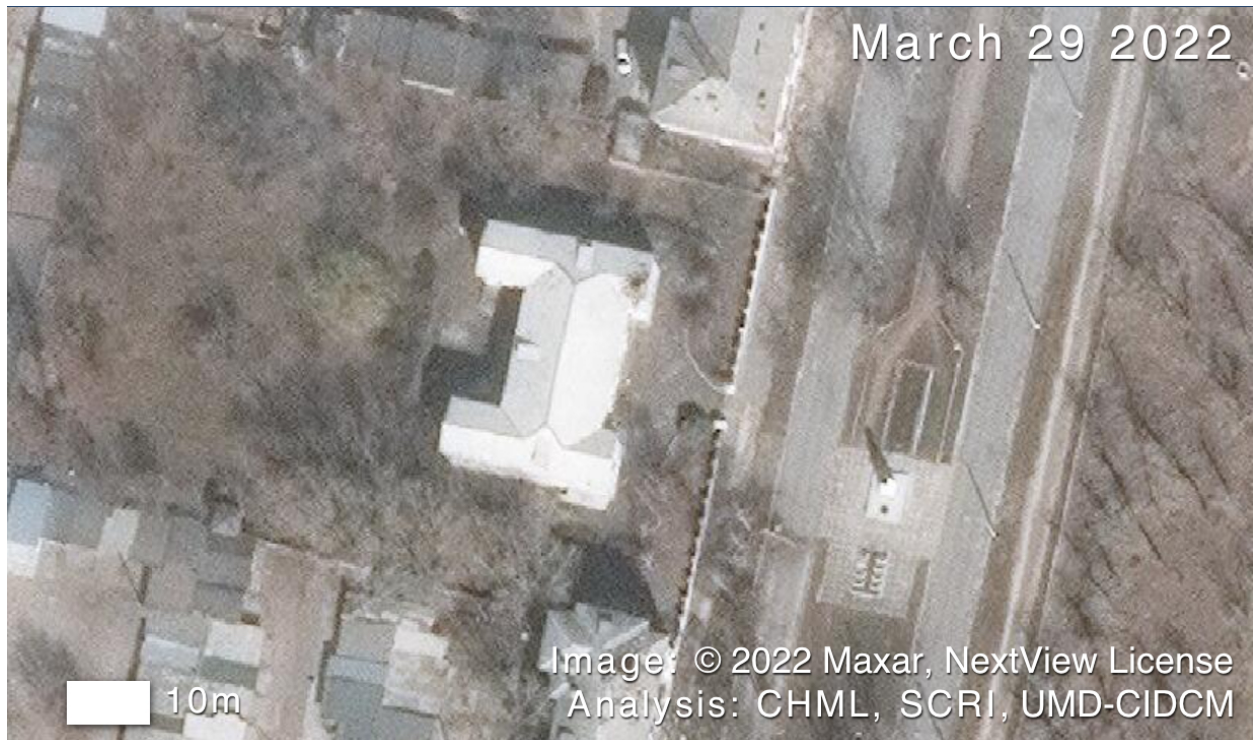
Figure 2:

Rubizhne City Museum (Рубіжанський міський музей) is a local history museum located in Rubizhne, Luhansk Oblast. The two-story building located adjacent to the Rubizhne City Park exhibits a collection of art and artifacts relevant to Rubizhne history and culture. Image from March 29, 2022 shows damage to the roof of the building. Image: © 2022 Maxar, NextView License.

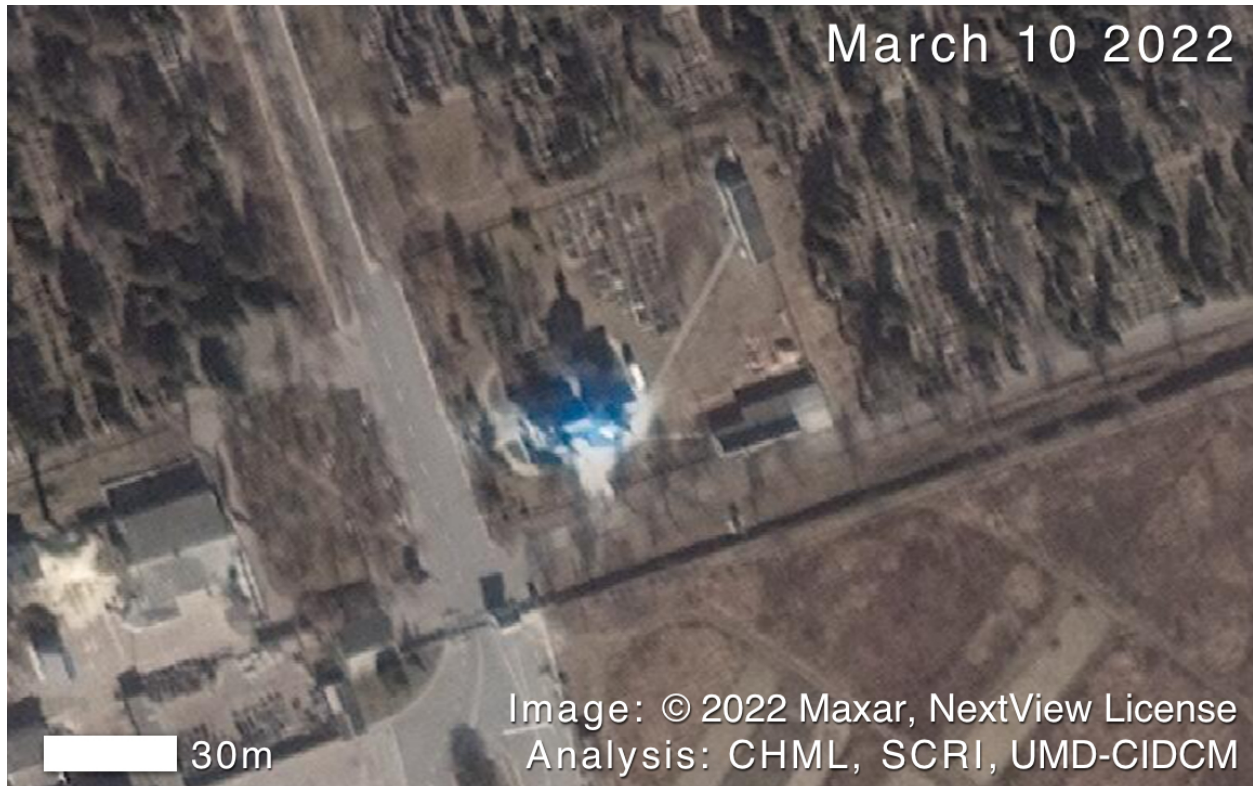
Figure 3:

Church of St. Theodosius (Церква святителя Феодосія) is a Ukrainian Orthodox Church located in Chernihiv, Chernihiv Oblast. The brick building was consecrated in 1996 and is located in the Yatsevo cemetery (Кладовище "Яцево"). Image from March 10, 2022 shows no visible damage. Image: © 2022 Maxar, NextView License.

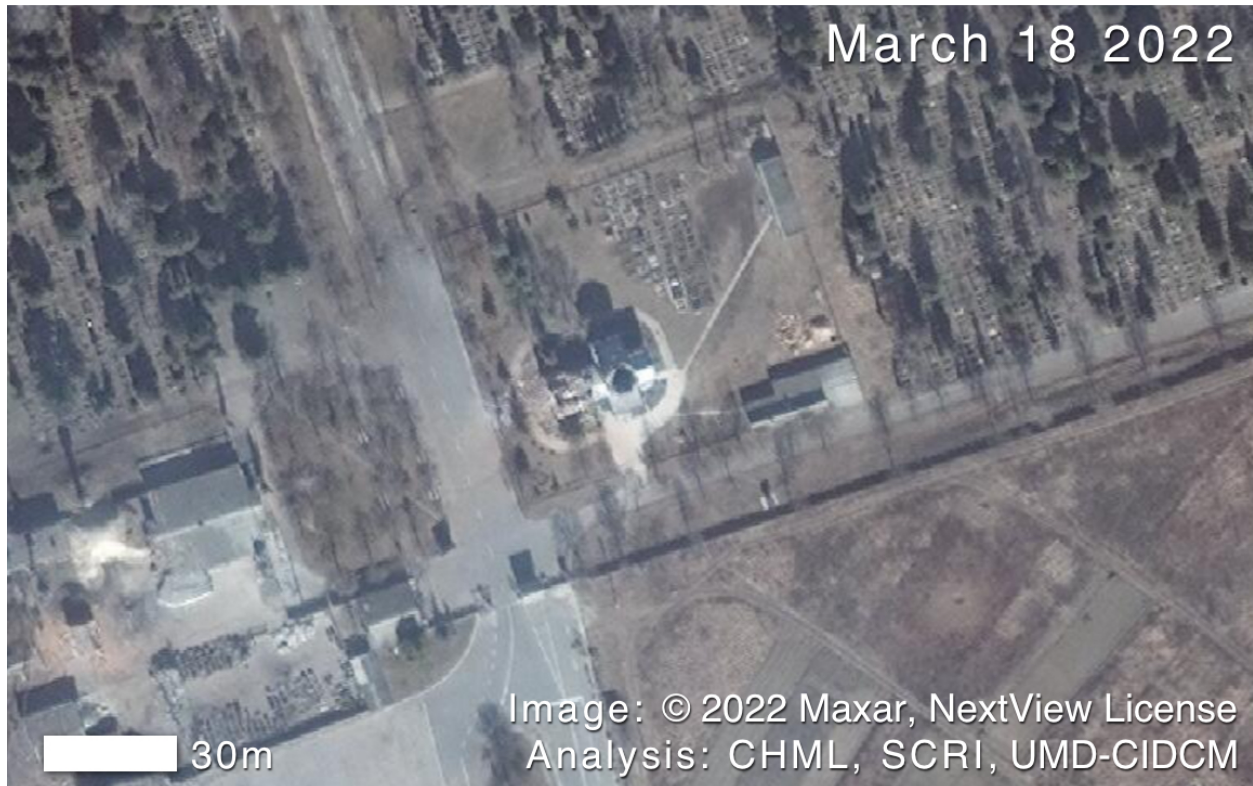
Figure 4:

Church of St. Theodosius (Церква святителя Феодосія) is a Ukrainian Orthodox Church in Chernihiv, Chernihiv Oblast. The brick building was consecrated in 1996 and is located in the Yatsevo cemetery (Кладовище "Яцево"). Image from March 18, 2022 shows damage to the building. Image: © 2022 Maxar, NextView License.

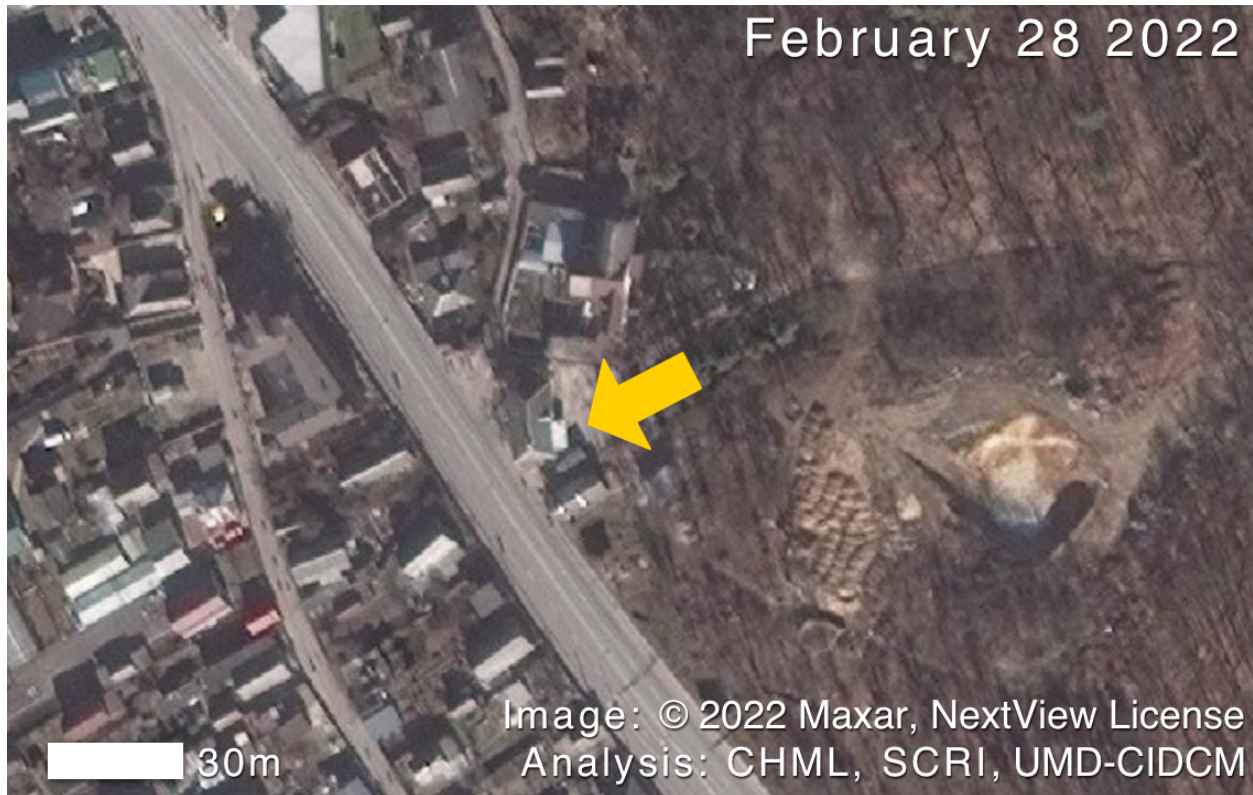
Figure 5:

Church of the Holy Prophet Elijah and the Apostle Andrew the First-Called (Храм Святих пророка Іллі та апостола Андрія) is a Ukrainian Orthodox Church located in Hostomel, Kyiv Oblast. The single-story building is located on European road E373. Image from February 28, 2022 shows no visible damage. Image: © 2022 Maxar, NextView License.

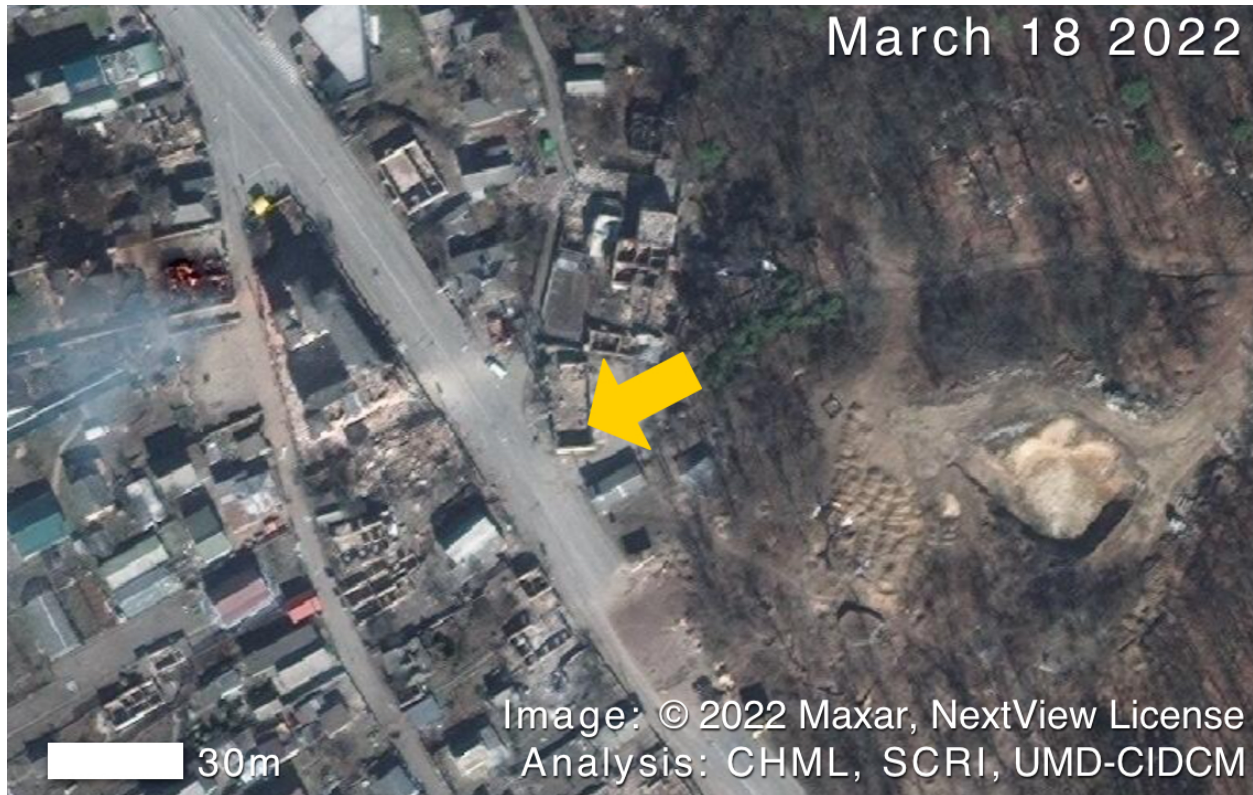
Figure 6:

Church of the Holy Prophet Elijah and the Apostle Andrew the First-Called (Храм Святих пророка Іллі та апостола Андрія) is a Ukrainian Orthodox Church located in Hostomel, Kyiv Oblast. The single-story building is located on European road E373. Image from March 18, 2022 shows damage to the building. Image: © 2022 Maxar, NextView License.

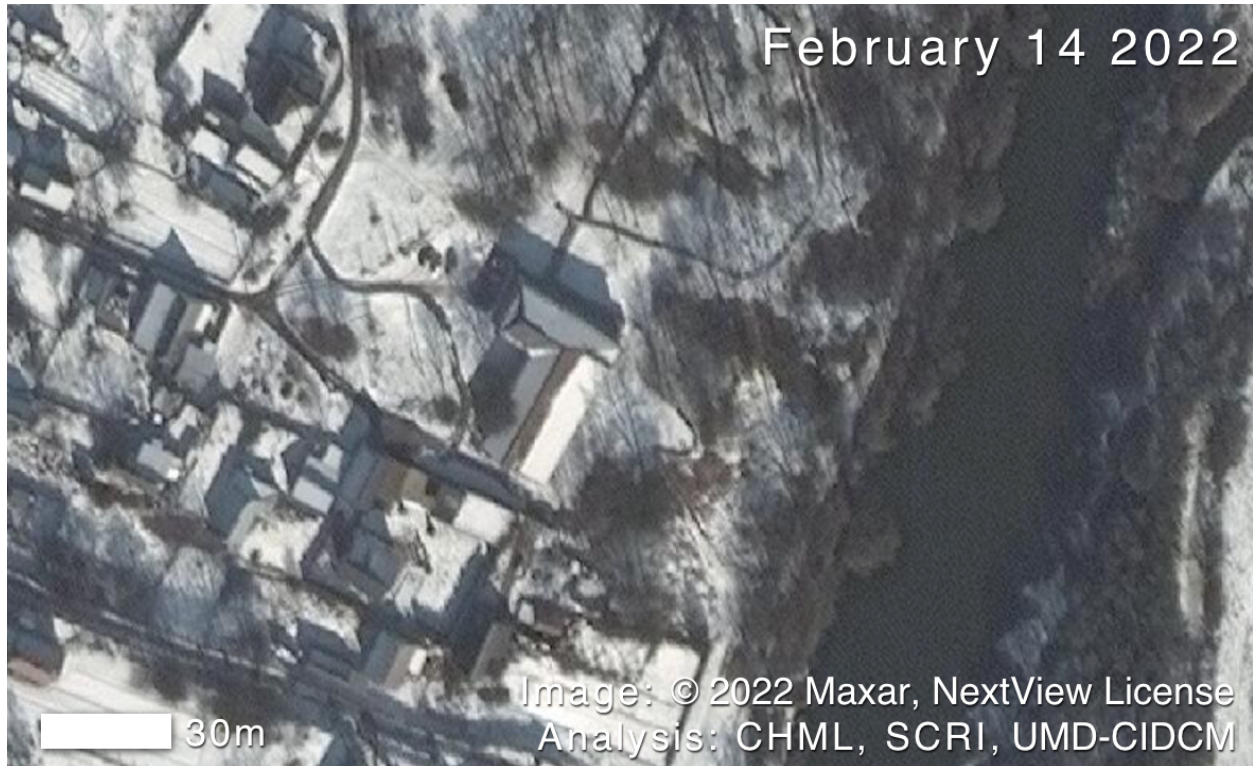
Figure 7:

Ivankiv Historical and Local History Museum (Іванківський Історико-краєзнавчий музей) is a local history museum located in Ivankiv, Kyiv Oblast. The museum was established in 1981 and displays art and artifacts relevant to the history and culture of Ivankiv. At the time of destruction, the museum served as a repository for a collection of paintings by Maria Ovkseiyivna Prymachenko, a Ukrainian painter and former resident of the Ivankiv district. There are conflicting accounts of how many paintings from this collection were present at the time of this damage. Image from February 14, 2022 shows no visible damage. Image: © 2022 Maxar, NextView License.

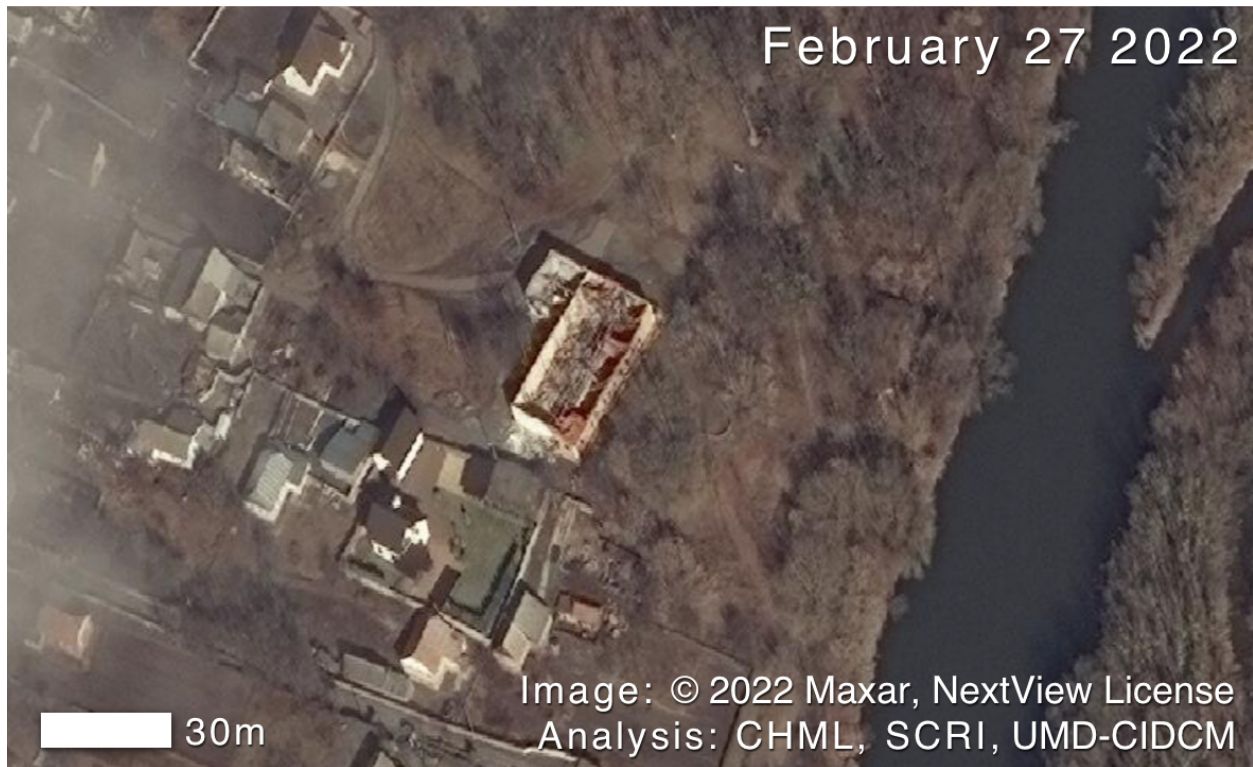
Figure 8:

Ivankiv Historical and Local History Museum (Іванківський Історико-краєзнавчий музей) is a local history museum located in Ivankiv, Kyiv Oblast. The museum was established in 1981 and displays art and artifacts relevant to the history and culture of Ivankiv. At the time of destruction, the museum housed a collection of paintings by Maria Ovksentiyivna Prymachenko, a Ukrainian painter and former resident of the Ivankiv district. Image from February 27, 2022 shows damage to the building. Image: © 2022 Maxar, NextView License.

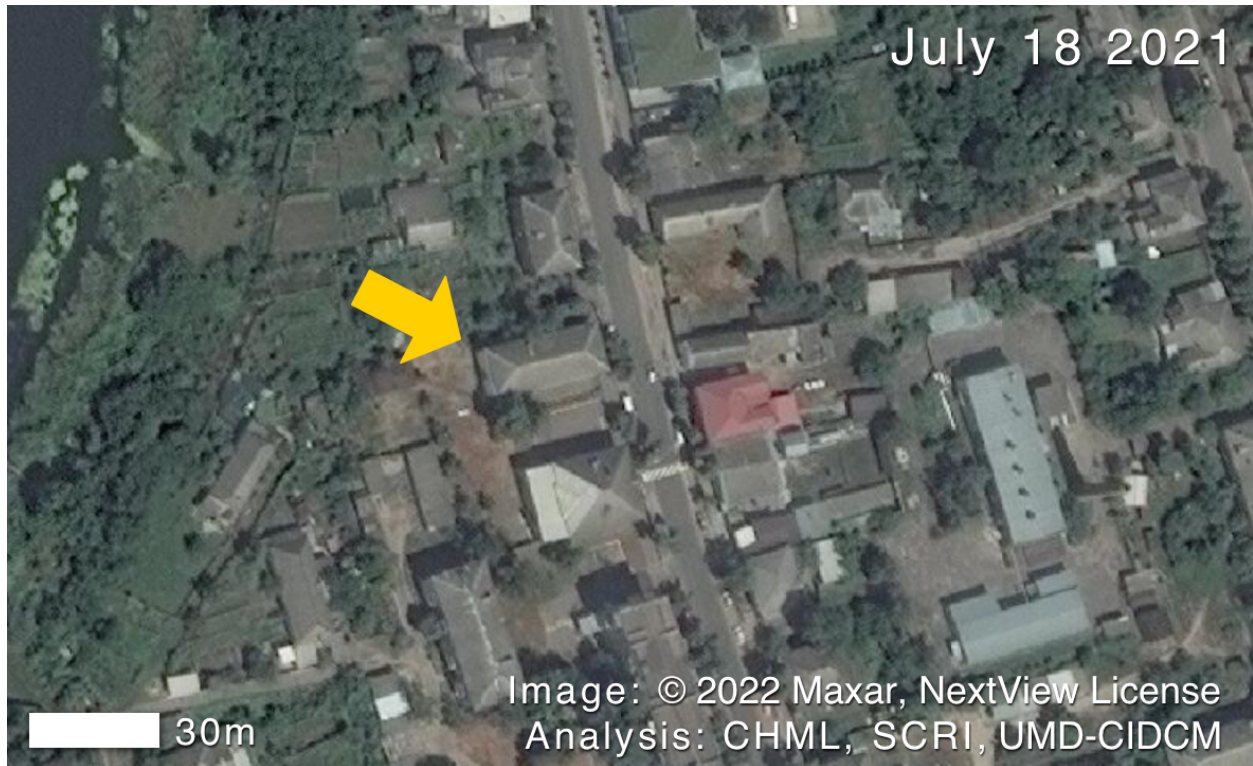
Figure 9:

Izyum Historical and Local History Museum, named after Mykola Vikentiyovych Sibilov (Ізюмський краєзнавчий музей імені М.В.Сібільова), is a local history museum located in Izyum, Kharkiv Oblast. The museum was established in 1920 and housed a collection of books, paintings, and works of art relevant to the history of the Slobozhanshchyna region. As a rural area, the region around Izyum has limited periodicity of pre-conflict imagery. Image from July 18, 2021 shows no visible damage. Image: © 2022 Maxar, NextView License.

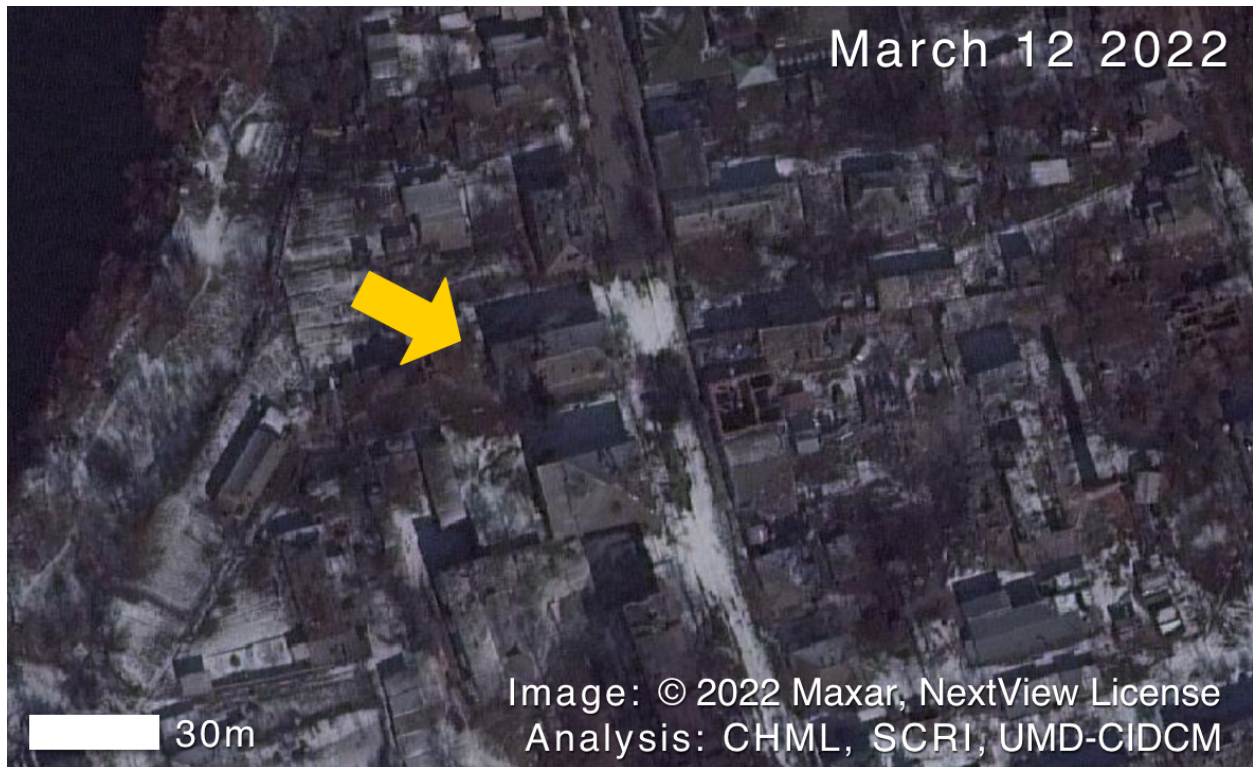
Figure 10:

Izyum Historical and Local History Museum, named after Mykola Vikentiyovych Sibilov (Ізюмський краєзнавчий музей імені М.В.Сібільова), is a local history museum located in Izyum, Kharkiv Oblast. The museum was established in 1920 and housed a collection of books, paintings, and works of art relevant to the history of the Slobozhanshchyna region. Image from March 12, 2022 shows some damage to the building. Image: © 2022 Maxar, NextView License.

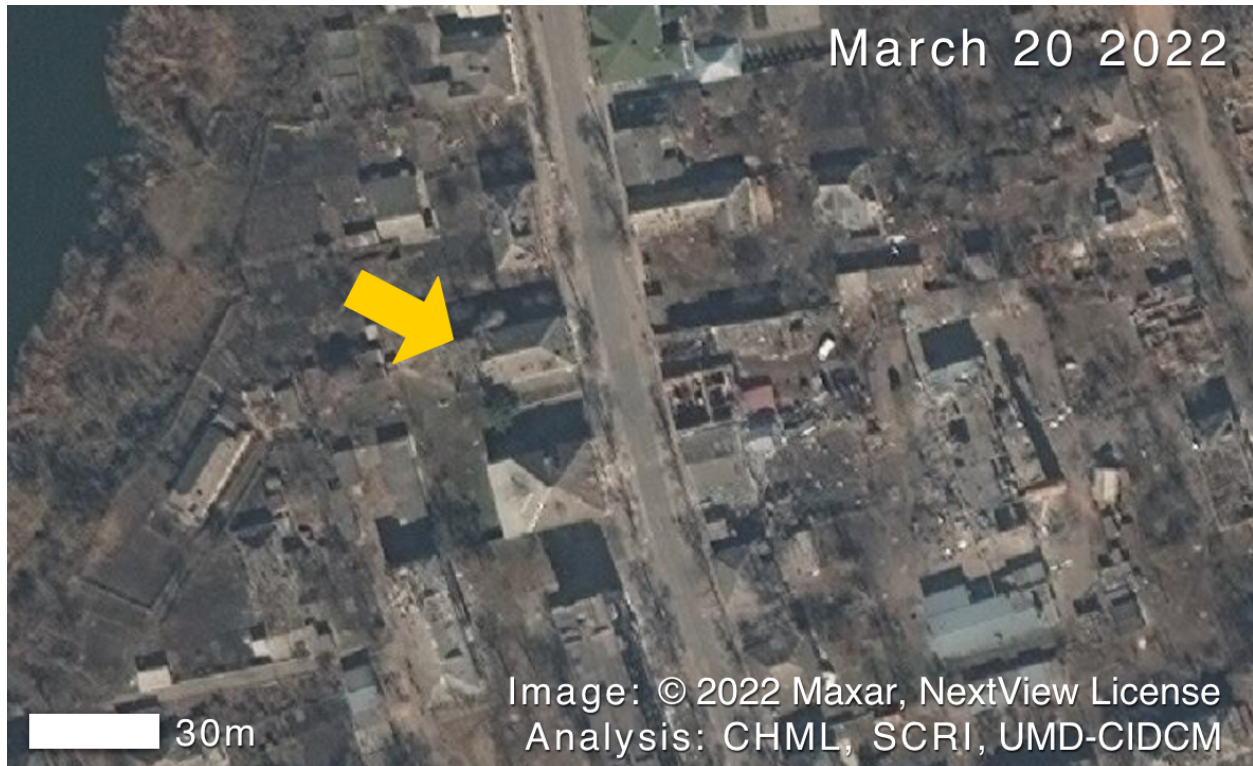
Figure 11:

Izyum Historical and Local History Museum, named after Mykola Vikentiyovych Sibilov (Ізюмський краєзнавчий музей імені М.В.Сібільова), is a local history museum located in Izyum, Kharkiv Oblast. The museum was established in 1920 and housed a collection of books, paintings, and works of art relevant to the history of the Slobozhanshchyna region. Image from March 20, 2022 shows additional damage to the building. Image: © 2022 Maxar, NextView License.

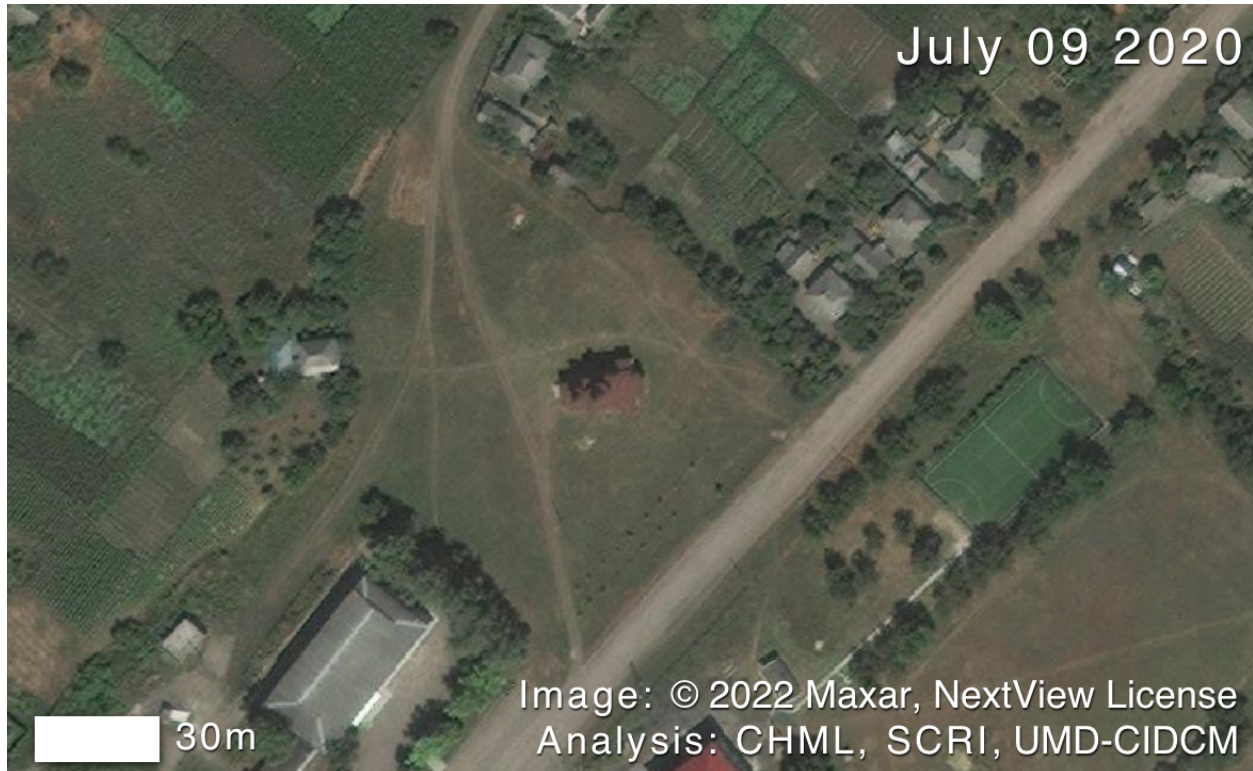
Figure 12:

Church in honor of the Holy Martyrs Faith, Hope, and Love and Their Mother Sophia (Храм на честь святих мучениць Віри, Надії, Любові та матері їх Софії) is a Ukrainian Orthodox Church located in the village of Kamyanka, Kharkiv Oblast. The church is constructed of wood and was consecrated in 2018 as part of the Diocese of Izyum. Image from July 09, 2020 shows no visible damage. Image: © 2022 Maxar, NextView License.

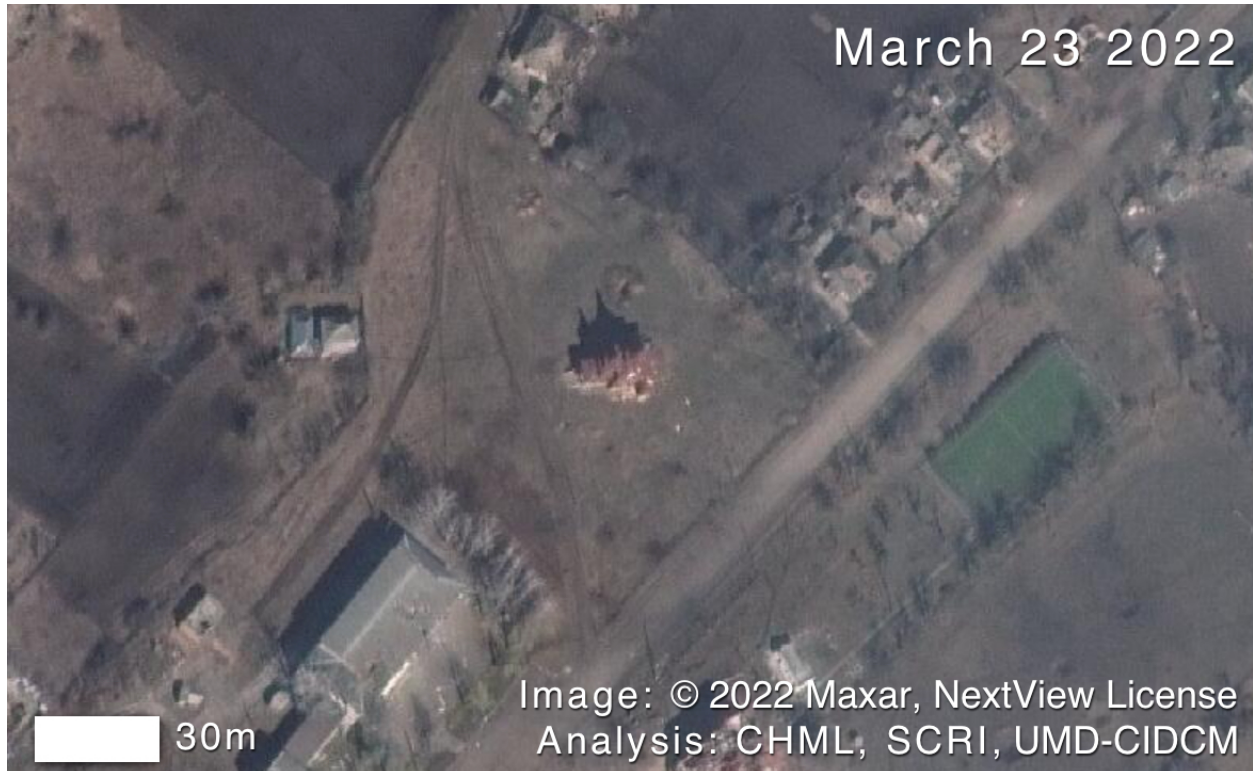
Figure 13:

Church in honor of the Holy Martyrs Faith, Hope, and Love and Their Mother Sophia (Храм на честь святих мучениць Віри, Надії, Любові та матері їх Софії) is a Ukrainian Orthodox Church located in the village of Kamyanka, Kharkiv Oblast. The church is constructed of wood and was consecrated in 2018 as part of the Diocese of Izyum. Image from March 23, 2022 shows damage to the building. Image: © 2022 Maxar, NextView License.

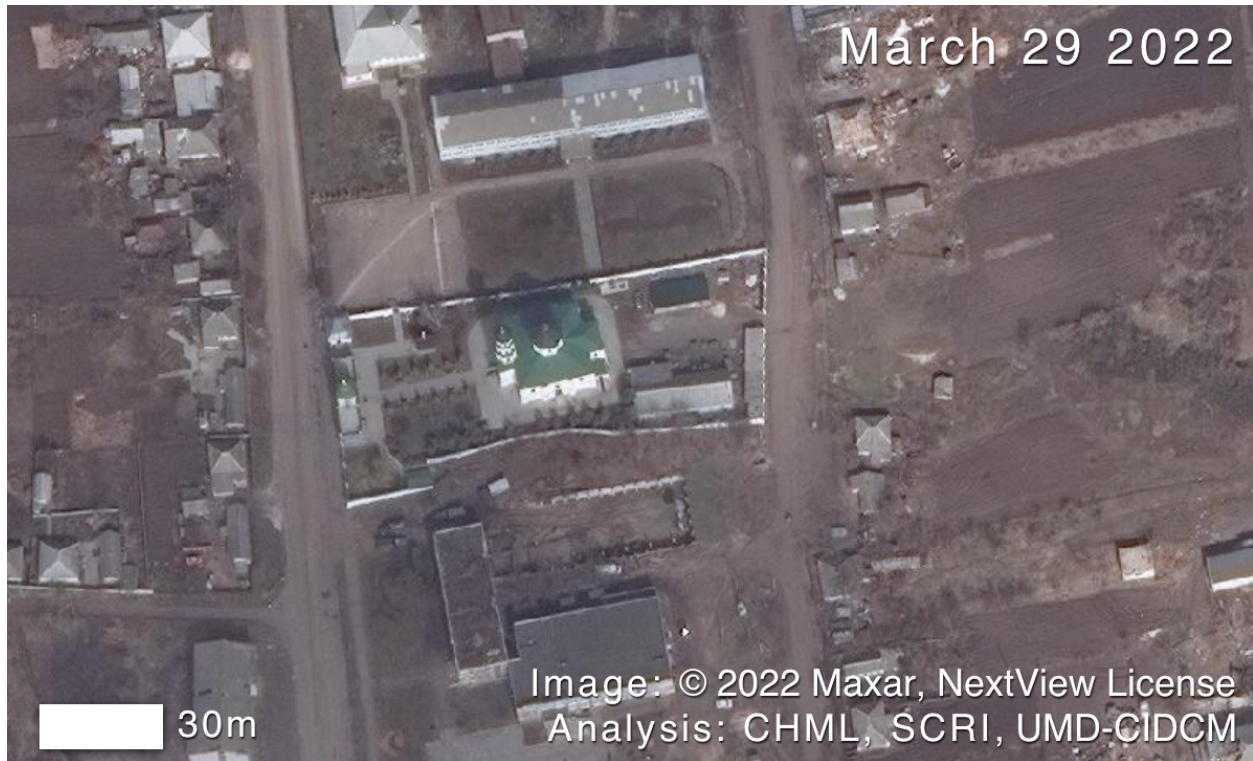
Figure 15:

St. Elijah's Monastery (Свято-Іллінський чоловічий монастир) is a Ukrainian Orthodox Church located in the village of Varvarivka, Luhansk Oblast. The church is part of the Diocese of Sievierodonetsk. Image from March 29, 2022 shows no visible damage. Image: © 2022 Maxar, NextView License.

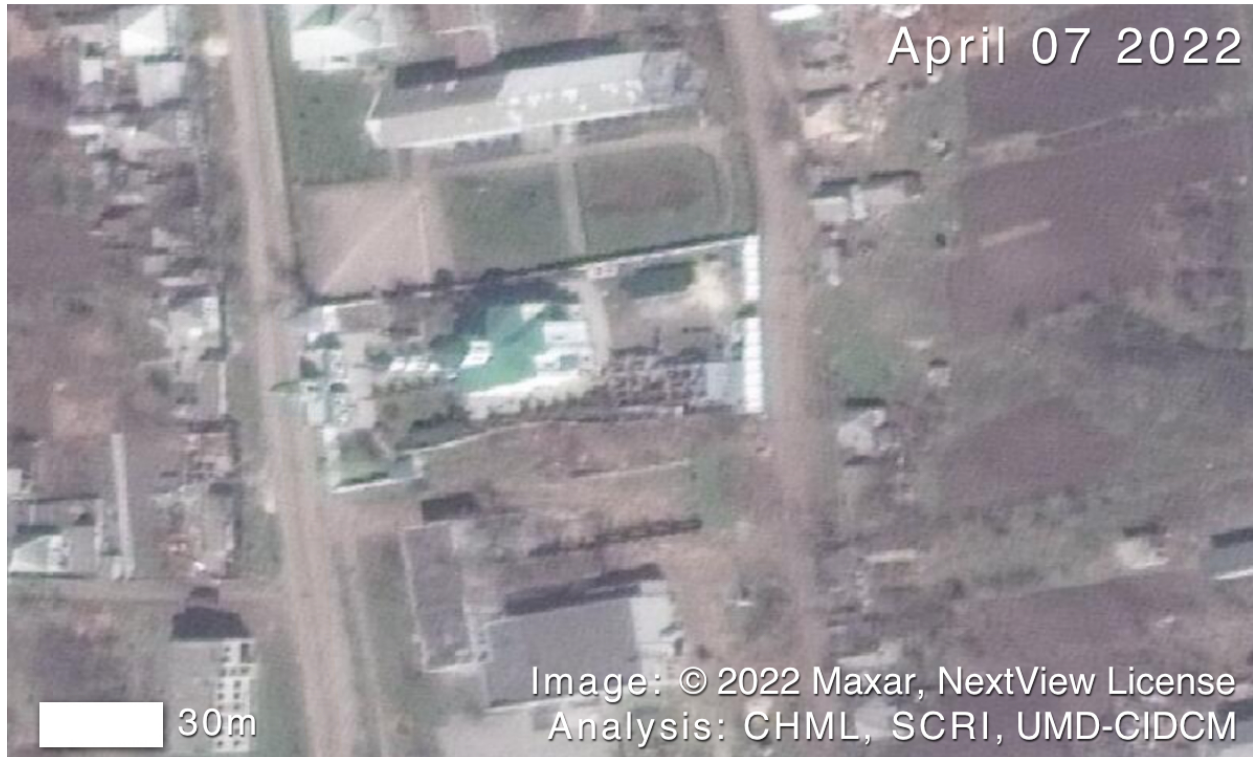
Figure 16:

St. Elijah's Monastery (Свято-Іллінський чоловічий монастир) is a Ukrainian Orthodox Church located in the village of Varvarivka, Luhansk Oblast. The church is part of the Diocese of Sievierodonetsk. Image from April 07, 2022 shows damage to the building. Image: © 2022 Maxar, NextView License.

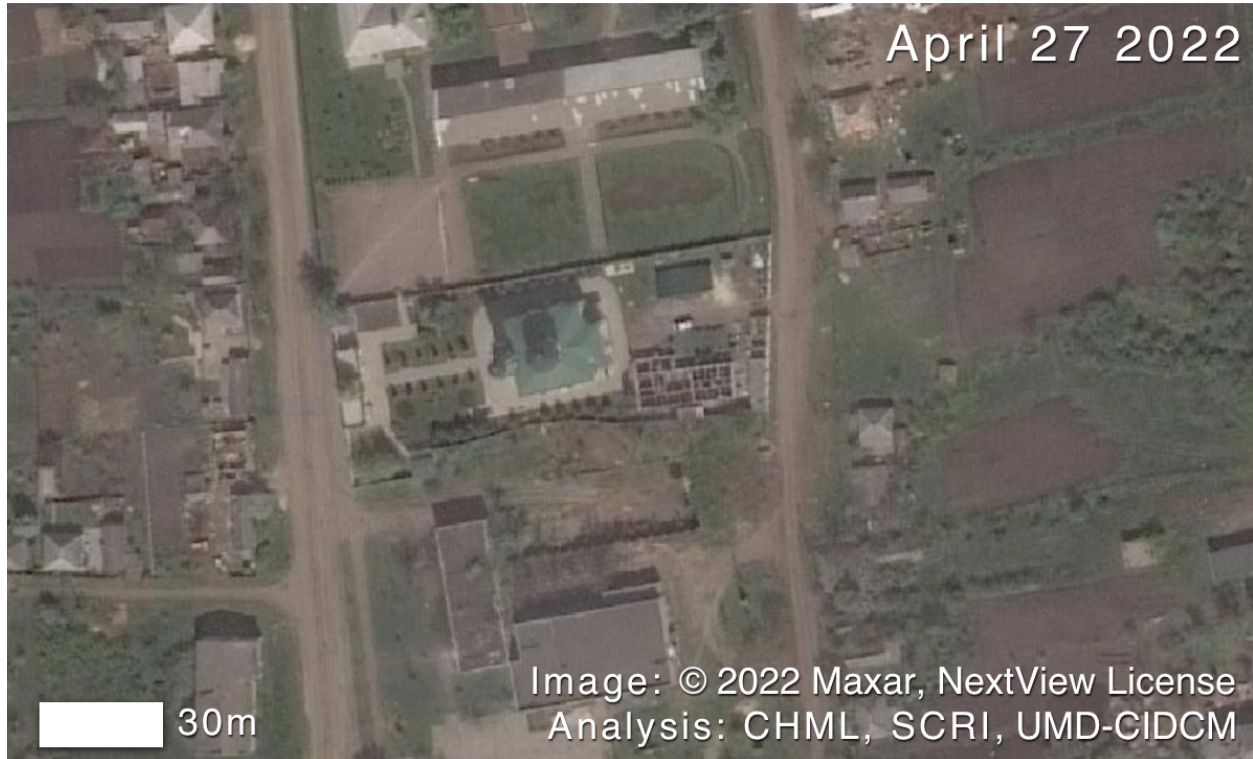
Figure 17:

St. Elijah's Monastery (Свято-Іллінський чоловічий монастир) is a Ukrainian Orthodox Church located in the village of Varvarivka, Luhansk Oblast. The church is part of the Diocese of Sievierodonetsk. Image from April 27, 2022 shows additional damage to the building. Image: © 2022 Maxar, NextView License.

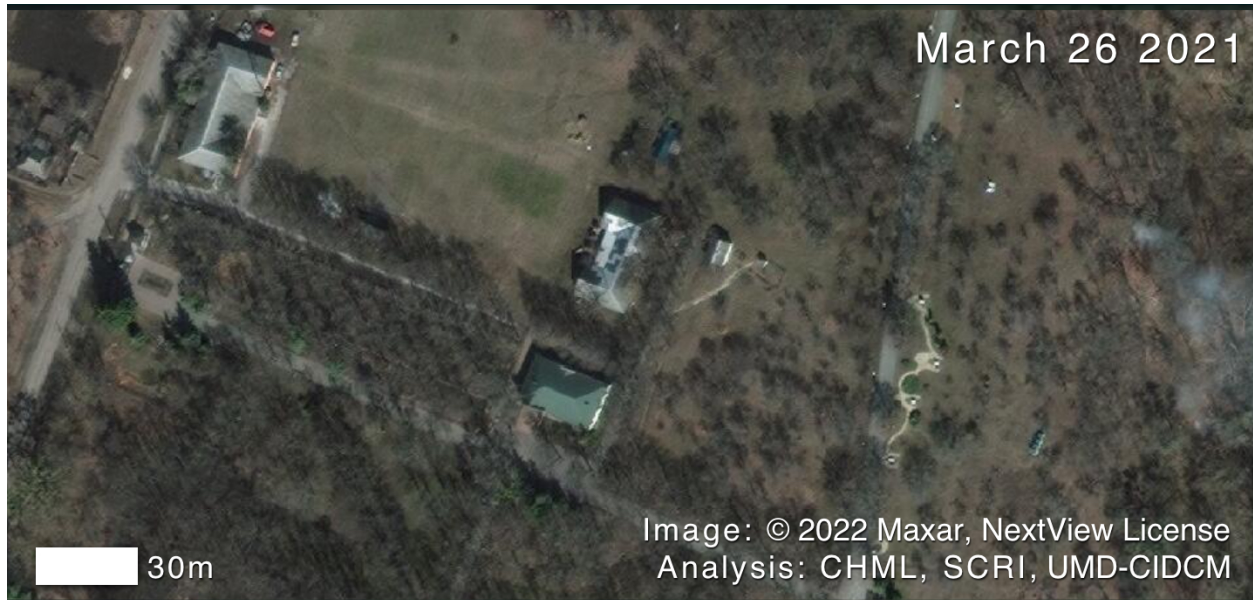
Figure 18:

Hryhorii Skovoroda Literary Memorial (Національний літературно-меморіальний музей Г. С. Сковороди) is a memorial museum located in Skovorodynivka village, Kharkiv Oblast. The museum is located in an 18th-century house and is dedicated to the life and work of Hryhorii Skovoroda, a Ukrainian philosopher. Image from March 26, 2021 shows no visible damage. Image: © 2022 Maxar, NextView License.

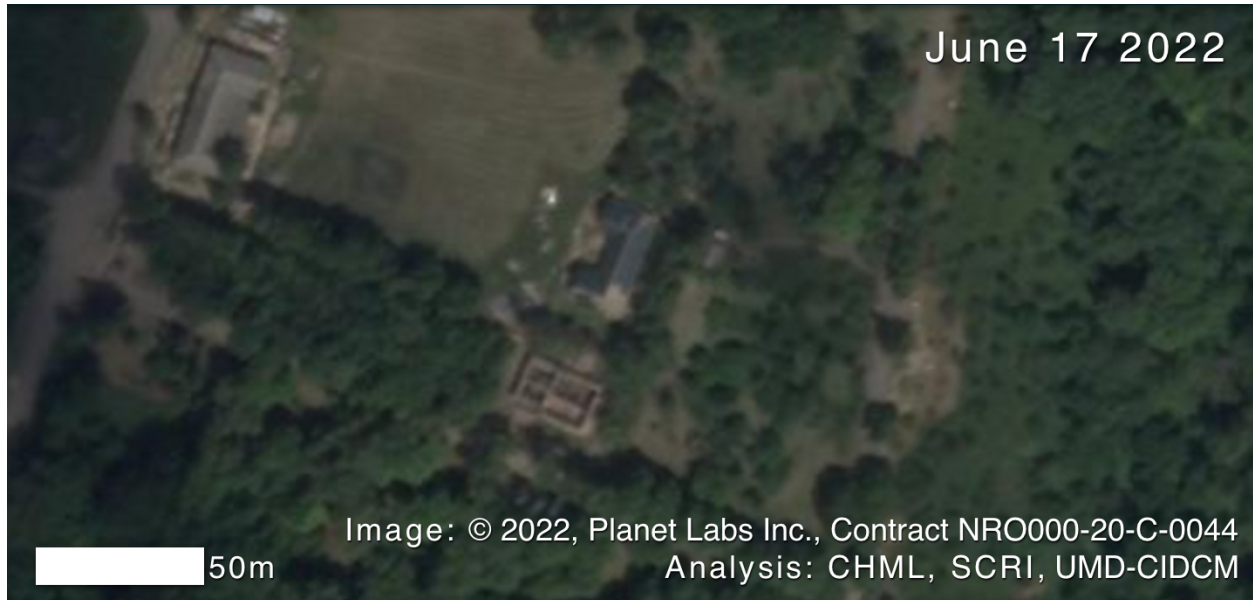
Figure 19:

Hryhorii Skovoroda Literary Memorial Museum (Національний літературно-меморіальний музей Г. С. Сковороди) is a memorial museum located in Skovorodynivka village, Kharkiv Oblast. The museum is located in an 18th-century house and is dedicated to the life and work of Hryhorii Skovoroda, a Ukrainian philosopher. Image from June 17, 2022 shows damage to the building. Image: © 2022, Planet Labs Inc., Contract NRO000-22-C-0247.

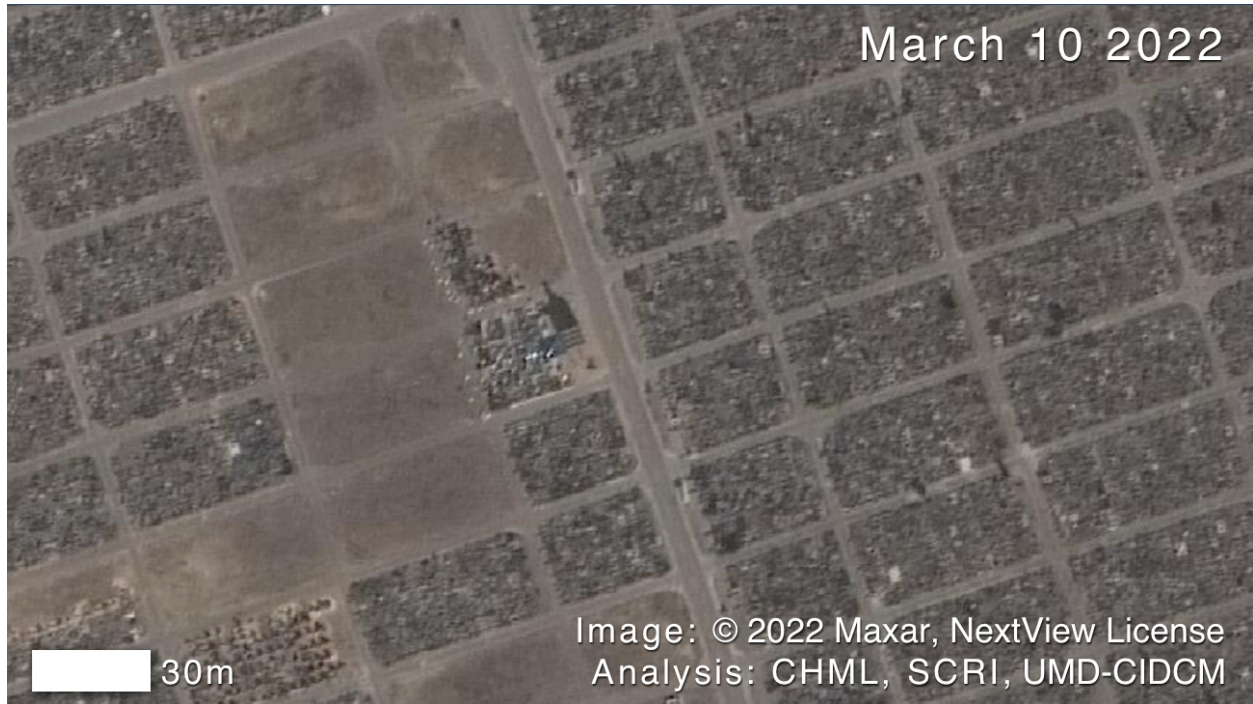
Figure 20:

The Yatsevo Cemetery (кладовище "Яцево") and Memorial Chapel of the Archangel Michael in honor of soldiers who died for Ukraine (Меморіальна каплиця Архистратига Божого Михаїла в честь воїнів, загиблих за Україну) are two cultural heritage sites located next to each other in the Chernihivs'kyi district of the Chernihiv Oblast. Image from March 10, 2022 shows no visible damage. Image: © 2022 Maxar, NextView License.

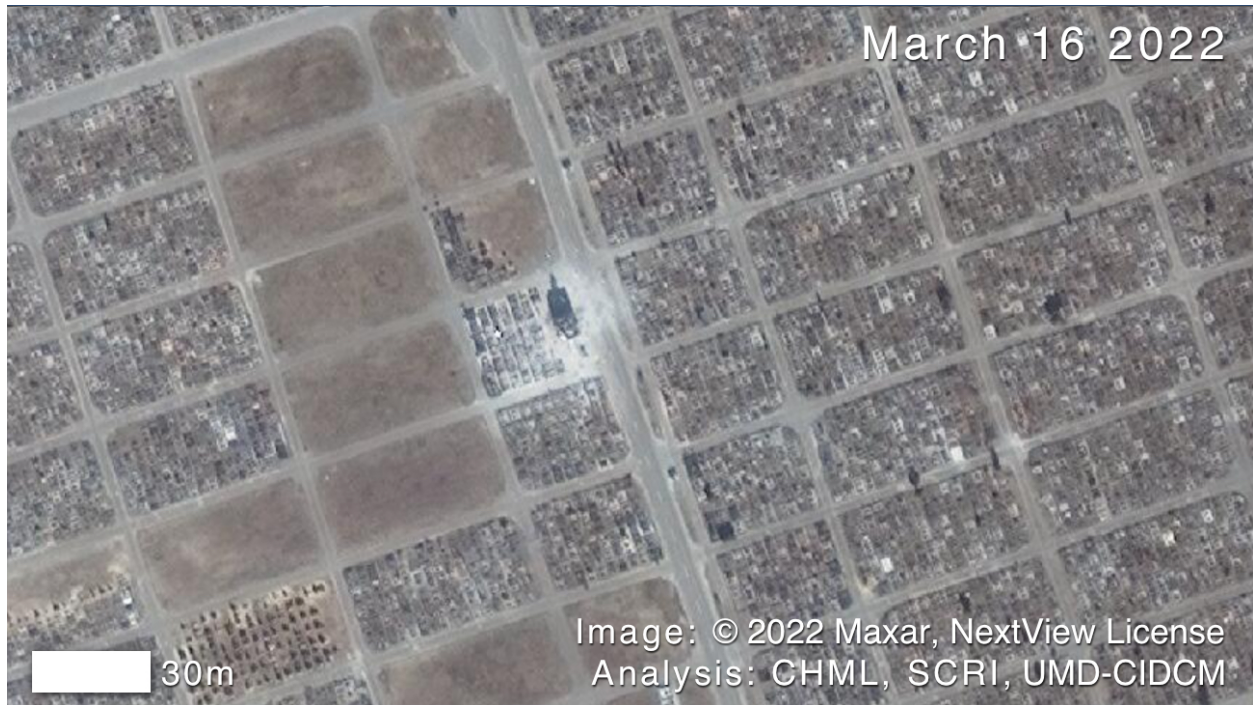
Figure 21:

The Yatsevo Cemetery (кладовище "Яцево") and Memorial Chapel of the Archangel Michael in honor of soldiers who died for Ukraine (Меморіальна каплиця Архистратига Божого Михаїла в честь воїнів, загиблих за Україну) are two cultural heritage sites located next to each other in the Chernihivs'kyi district of the Chernihiv Oblast. Image from March 16, 2022 shows damage to both sites visible in the change in shadow of the shrine's profile and the debris field from the shrine impact spilling into the street. Image: © 2022 Maxar, NextView License.

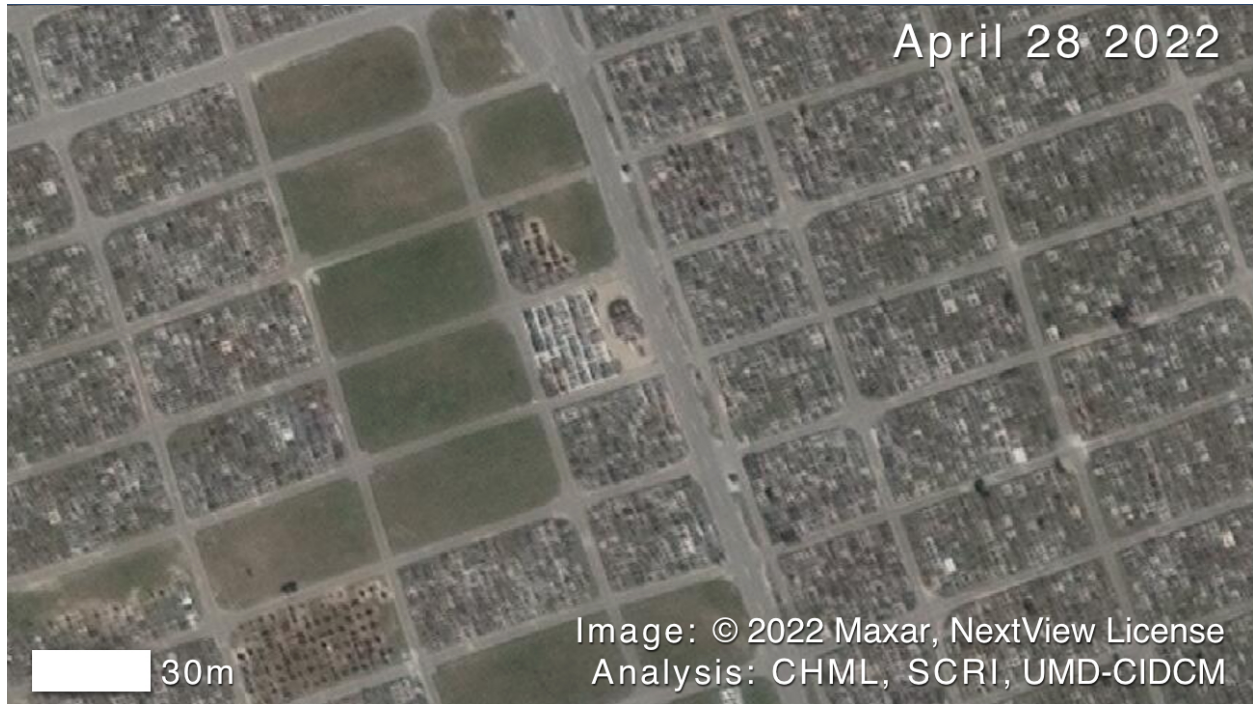
Figure 22:

The Yatsevo Cemetery (кладовище "Яцево") and Memorial Chapel of the Archangel Michael in honor of soldiers who died for Ukraine (Меморіальна каплиця Архистратига Божого Михаїла в честь воїнів, загиблих за Україну) are two cultural heritage sites located next to each other in the Chernihivs'kyi district of the Chernihiv Oblast. Image from April 28, 2022 shows additional damage to both sites. Image: © 2022 Maxar, NextView License.
