**Damage Assessment of Health and Educational Facilities in
Sievierodonetsk Raion, Ukraine:**

**Evidence of Widespread, Indiscriminate, and Persistent
Bombardment by Russia and Russia-Aligned Forces
Between 24 February - 13 June 2022**

Issued 29 June 2022

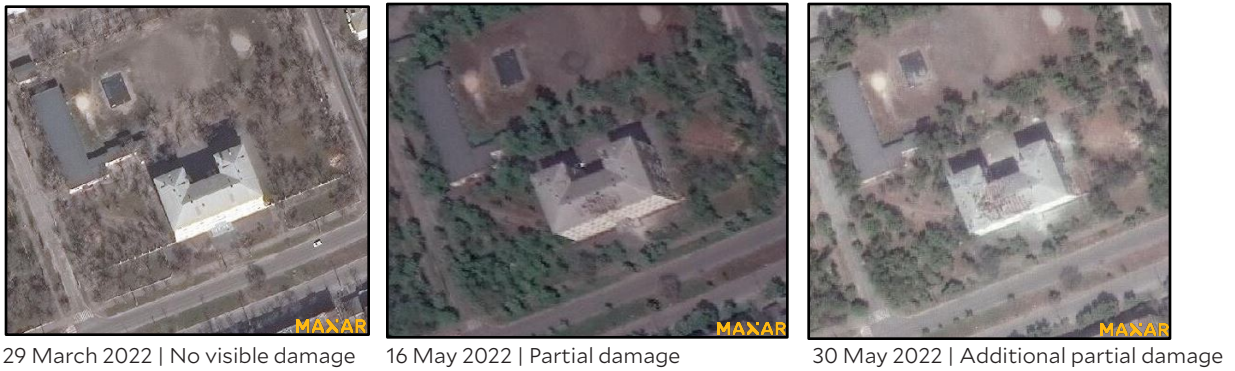
Figure 1: Observable Waves of Damage

The first image (left) was captured on 29 March 2022 (no visible damage), the second image (center) was captured on 16 May 2022 and shows partial damage, and the third image (right) was captured on 30 May 2022 and shows additional partial damage. These images are of the same facility and multiple iterations of damage are clearly visible.

The above images were captured on 29 March 2022, 16 May 2022, and 30 May 2022, respectively (left to right). These images demonstrate the incremental increase in damage to the roof of the facility. This indicates that the facility incurred damage on at least two separate occasions. It is not possible to conclude exactly how many separate instances of damage occurred to a facility given two images separated by an extended time period. However, the chronological analysis of available imagery for the reporting period indicates the minimum number of occasions on which an identified location incurred damage. Analysts were able to conclude that this facility incurred damage on at least one occasion between 29 March 2022 and 16 May 2022 and on at least occasion between 16 May 2022 and 30 May 2022; meaning that it sustained at least two waves of damage.

For facilities consisting of more than one building, this report defines the number of minimum “waves” of damage at a facility by the number of times satellite imagery captures any change in damage to at least one building within that facility. In short, a building in a facility at which there were at least two waves of damage may not necessarily have been hit at least two times. Rather, a building in a facility at which there were at least two waves of damage may have incurred damage two, one, or no times; if a satellite image captures increased damage to at least one building within a facility compared to previously available imagery, a wave of damage is counted.

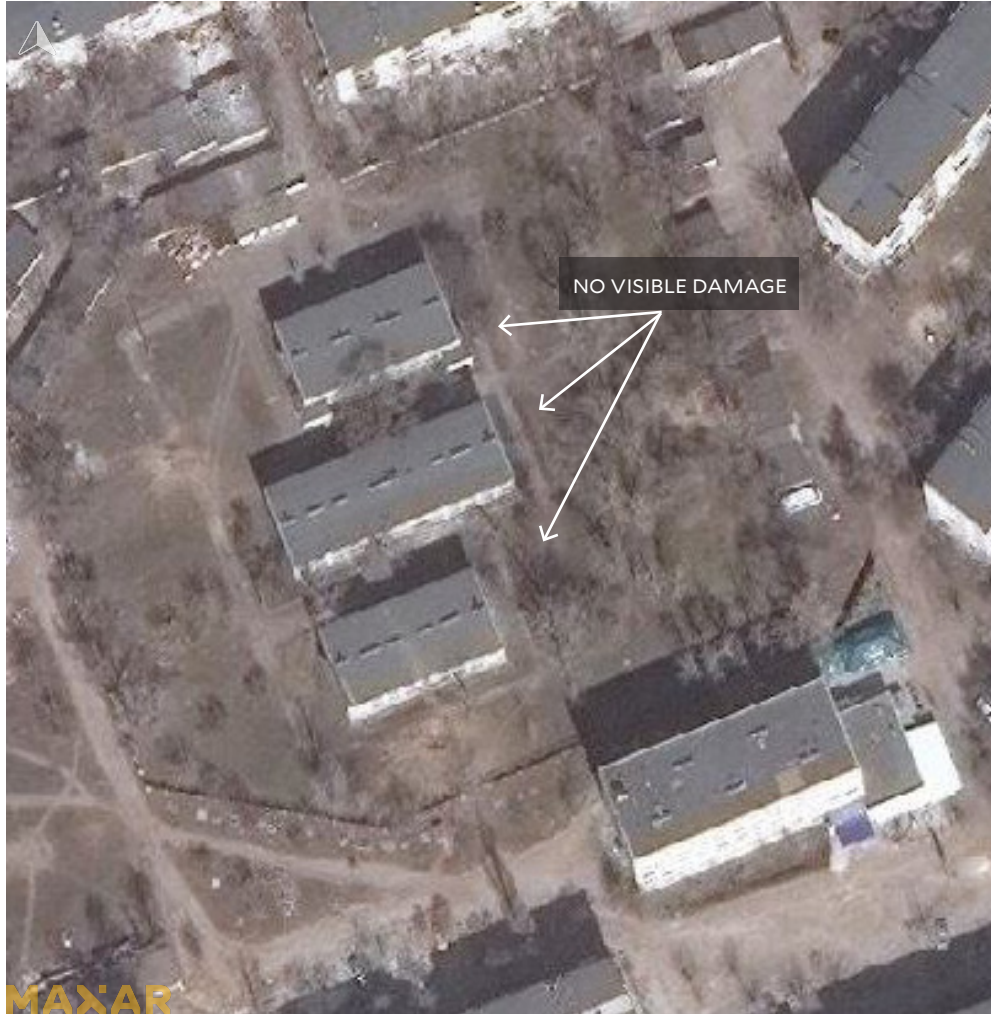
Date: 2022.03.29
Source: WV03
Ground Sampling Distance: 34 cm
Off-Nadir: 17.4842°

Image from 2022.03.29 shows the roofs of the resource center without visible damage. Other nearby buildings appear intact.

NO VISIBLE DAMAGE

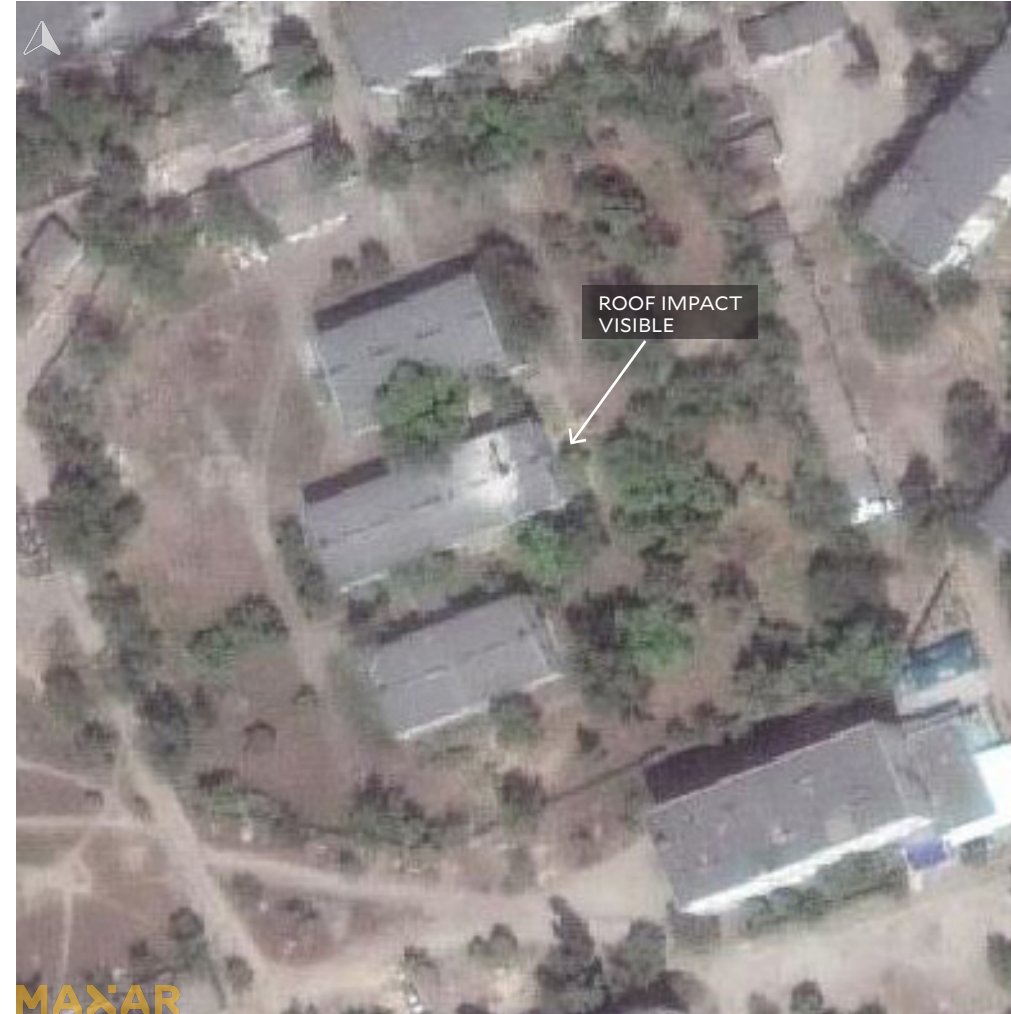
Date: 2022.05.30
Source: GEO1
Ground Sampling Distance: 44 cm
Off-Nadir: 14.8564°

Image from 2022.05.30 shows visible changes consistent with impact to the roof.

MINIMAL DAMAGE

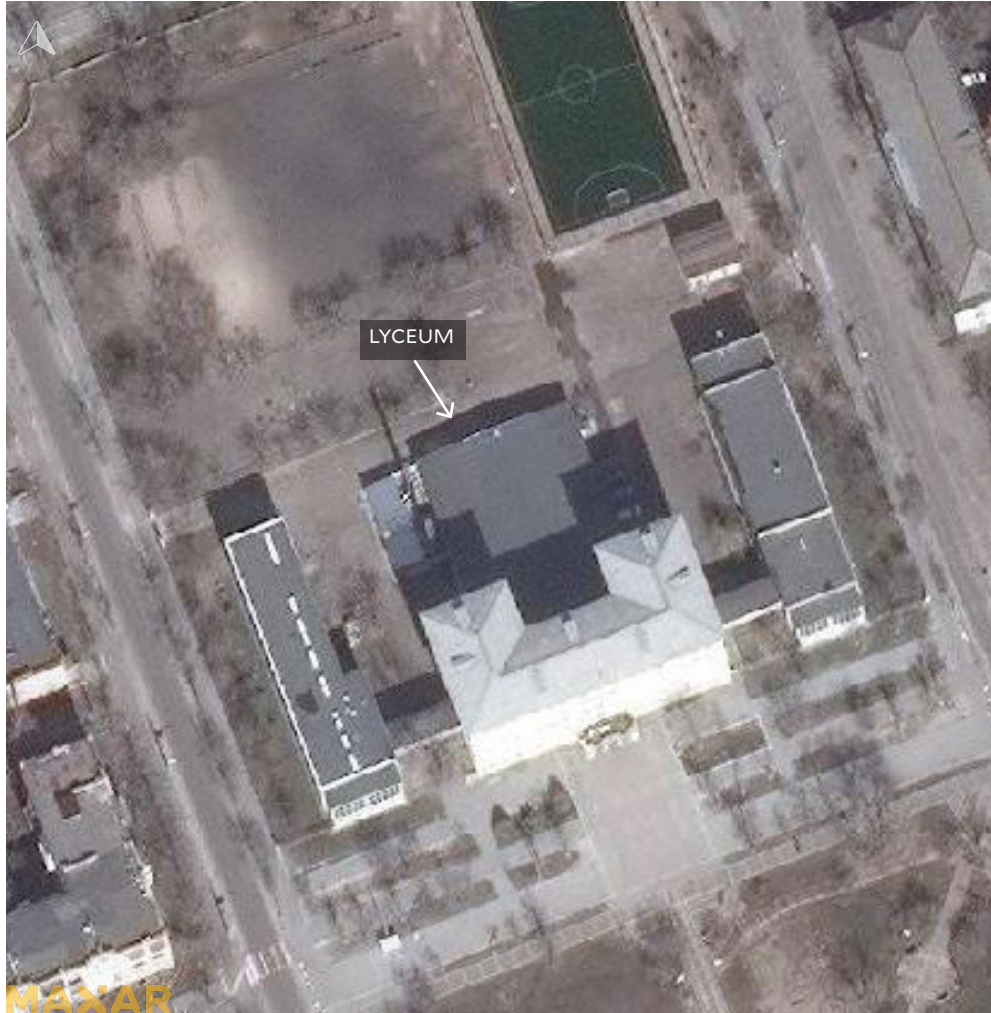
LYCEUM “COLLEGIUM” | ЛІЦЕЙ “КОЛЕГІУМ”

Image from 2022.03.29 shows the lyceum without visible damage. Other nearby buildings appear intact.

NO VISIBLE DAMAGE

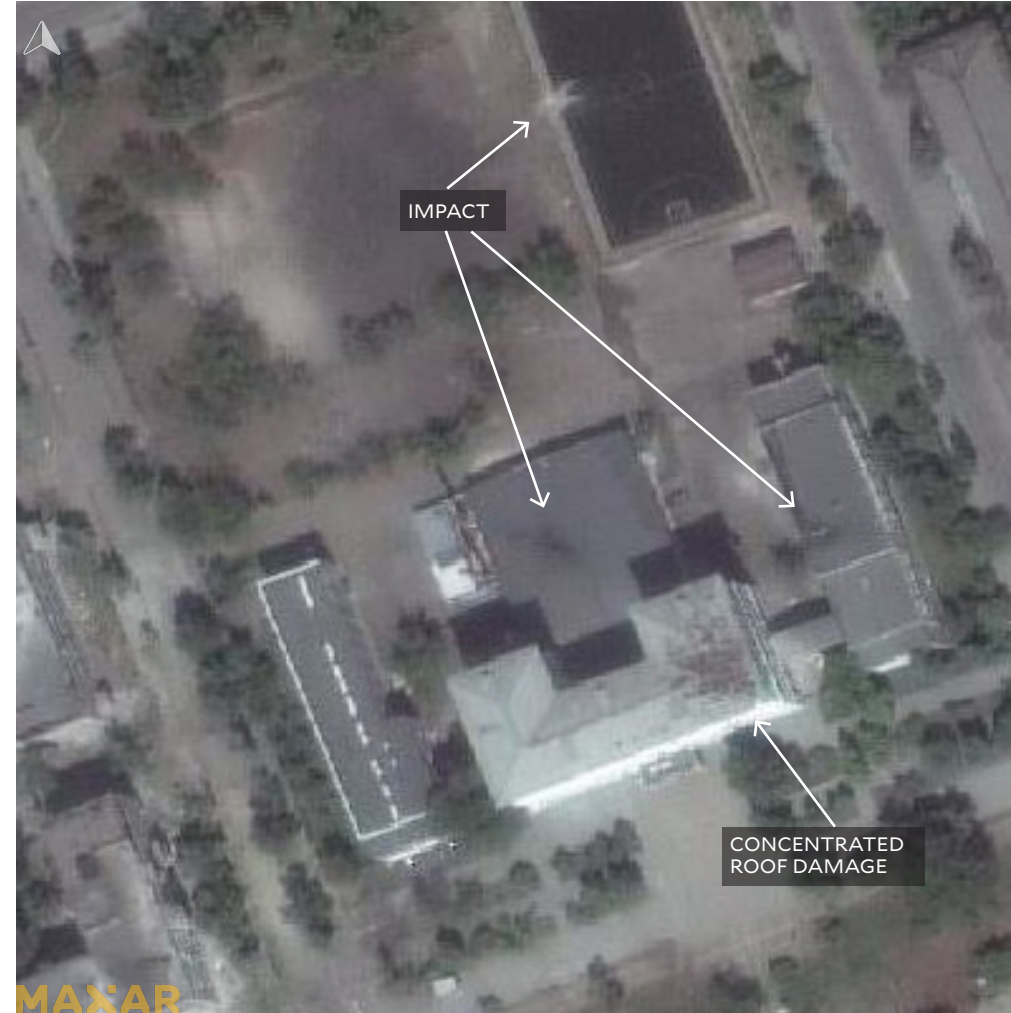
Image from 2022.06.06 shows visible indicators of impact consistent with bombardment and clustered damage to a significant portion of the central lyceum structure's roof.

PARTIAL DAMAGE

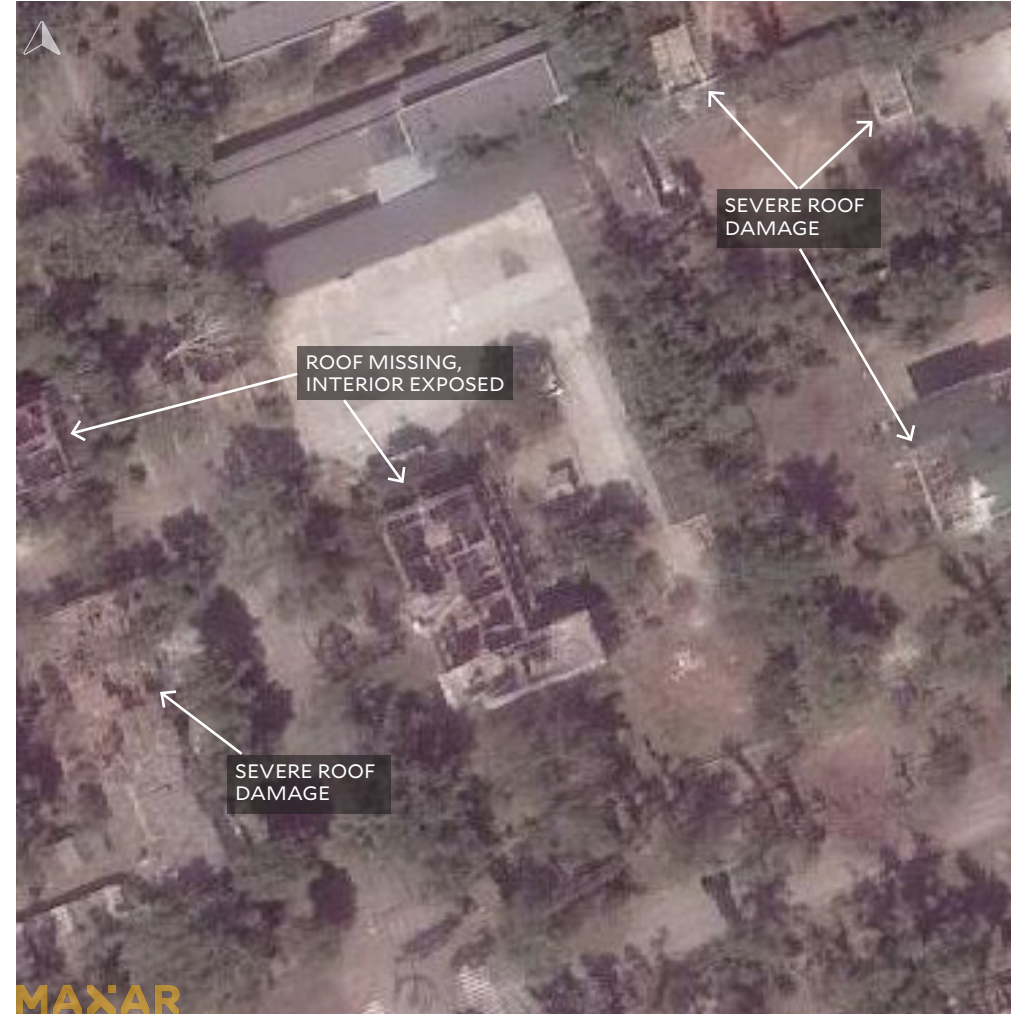
Date: 2022.06.06
Source: WV03
Ground Sampling Distance: 39 cm
Off-Nadir: 28.9469°

Image from 2022.06.06 shows that the main station structure no longer has a roof, leaving its interior exposed. Nearby buildings have visible roof damage or are missing roofs.

TOTAL DAMAGE

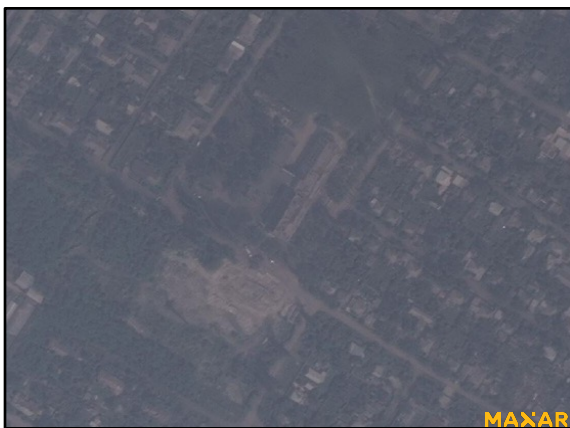
Figure 1: Examples of Low Visibility

8 April 2022 | Haze

OBSTRUCTIVE FACTORS IMAGE ANALYSIS	
Type	Effect
Cloud cover	Partial/complete obstruction of image
Ground fog/mist/smog	Image blurring
Snow fall	Masking damage
Varying angles of capture	Difficulty comparing tiles; damage obscured by shadows; only coverage of one side of buildings
Deciduous trees & other vegetation	Difficulty comparing tiles

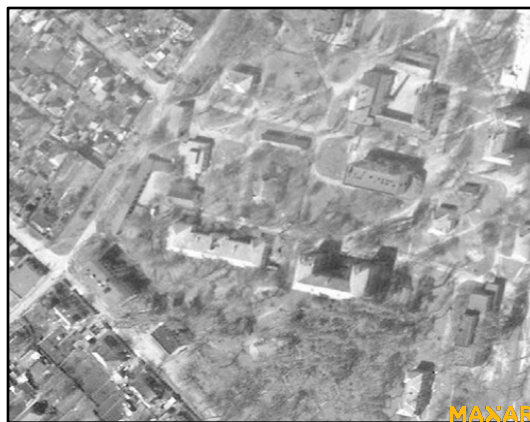
11 June 2022 | Poor contrast
